**NESHAP RENOVATION / DEMOLITION INSPECTION OF
ASBESTOS CONTAINING MATERIALS
AND OTHER HAZARDOUS WASTE MATERIALS**

1154 Cleveland
Lincoln Park, MI 48146

City of Lincoln Park
1355 Southfield Road
Lincoln Park, MI 48146
313-386-1817

8/9/2019
Date of Survey

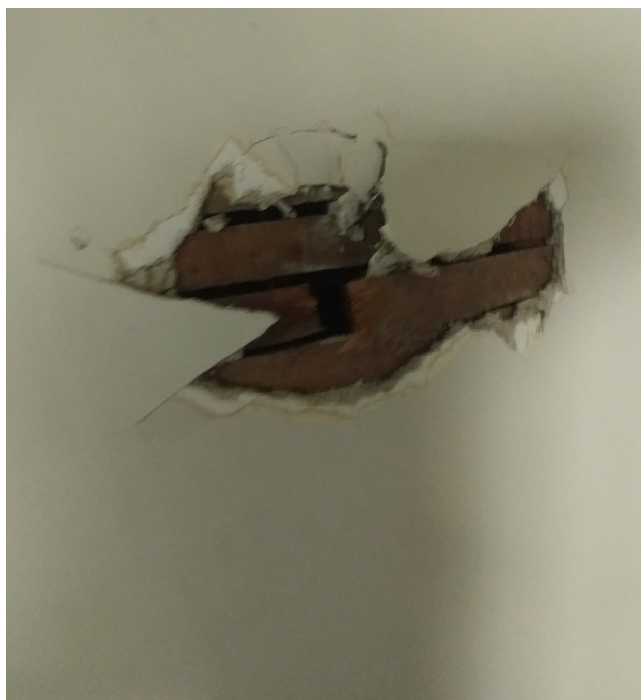
Pos. Plaster

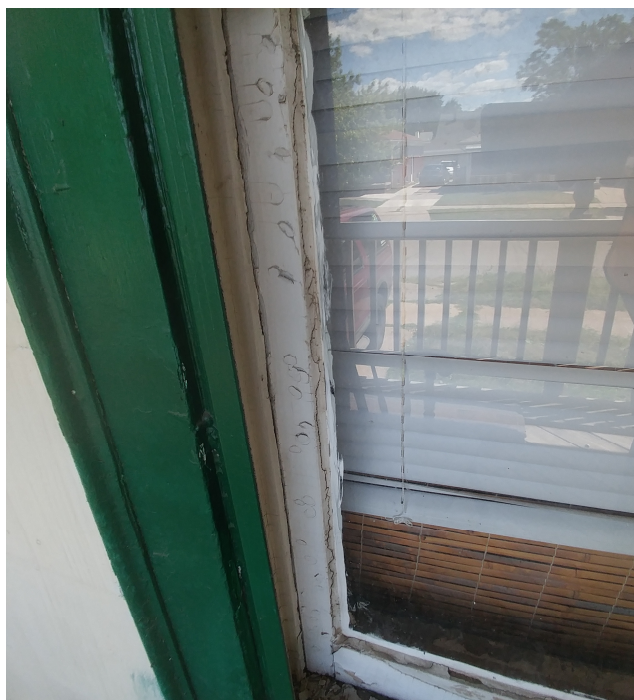
Pos. Window Glaze

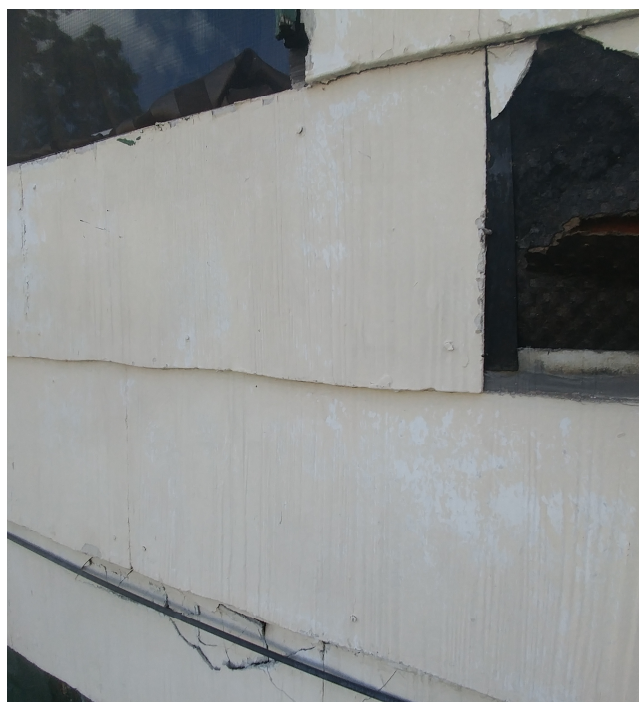
Pos. Transite

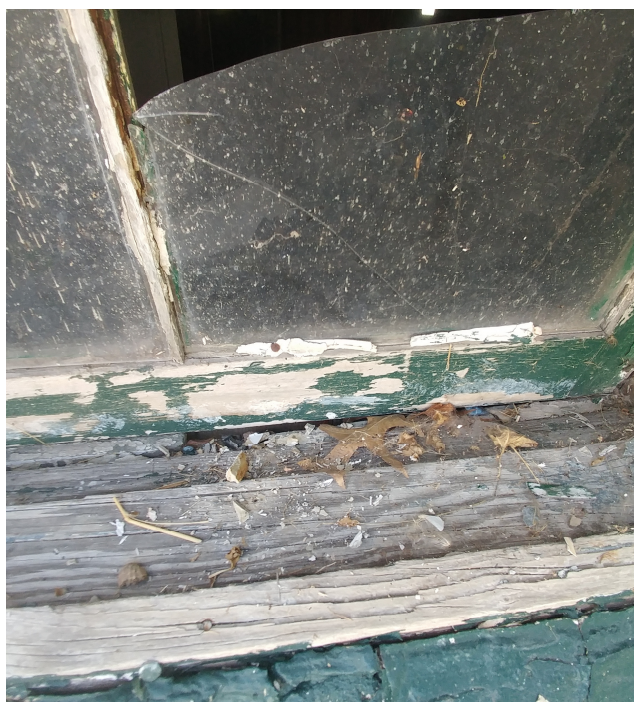
Pos. Basement Window Glaze
