**NESHAP RENOVATION / DEMOLITION INSPECTION OF  
ASBESTOS CONTAINING MATERIALS  
AND OTHER HAZARDOUS WASTE MATERIALS**

1360 Montie  
Lincoln Park, MI 48146

Connor Beausejour  
Michigan Certification #: A-51686  
Environmental Testing & Consulting, Inc.  
38900 West Huron River Drive  
Romulus, Michigan 48174  
(734) 955-6600  
ETC Job #: 224362

8/19/2019  
**Date of Report**

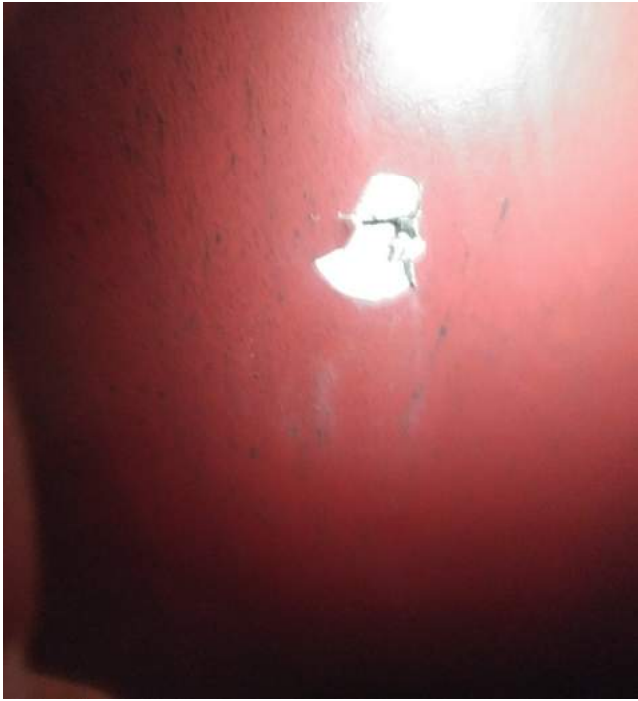
Pos. Plaster

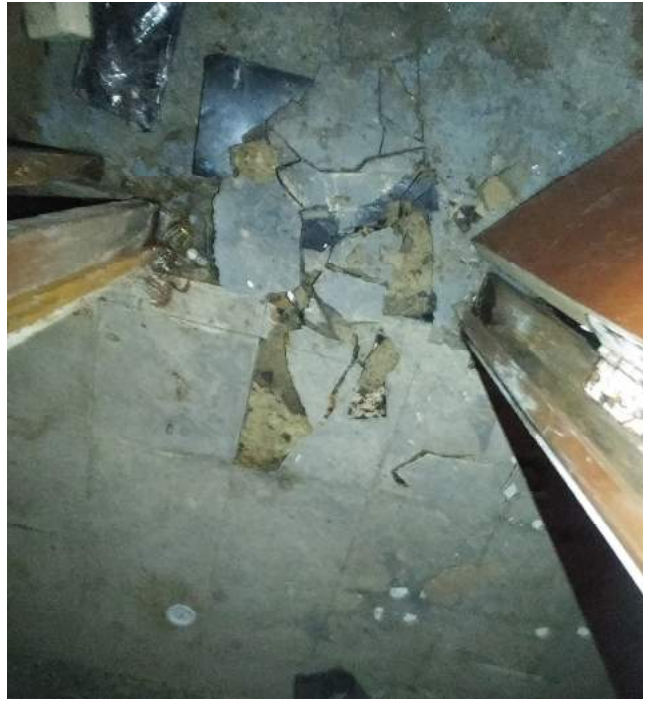
Pos. Floor Tile, 9x9

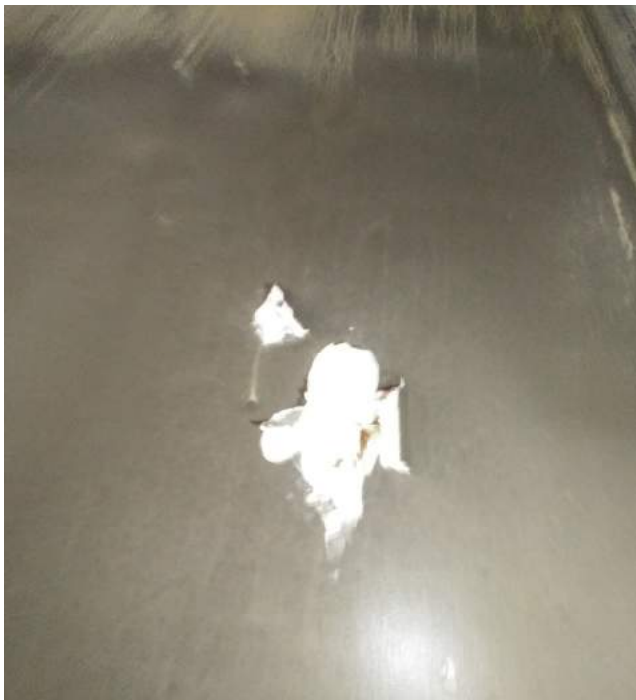
Pos. Drywall
