**NESHAP RENOVATION / DEMOLITION INSPECTION OF
ASBESTOS CONTAINING MATERIALS
AND OTHER HAZARDOUS WASTE MATERIALS**

1775 Ford
Lincoln Park, MI 48146

Connor Beausejour
Michigan Certification #: A-51686
Environmental Testing & Consulting, Inc.
38900 West Huron River Drive
Romulus, Michigan 48174
(734) 955-6600
ETC Job #: 224364

08/15/2019
Date of Report

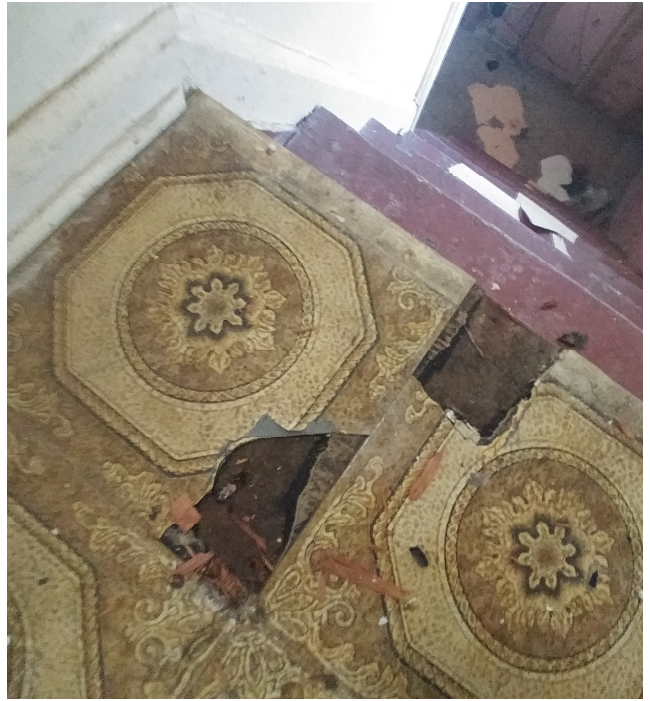
Pos. 12X12 Floor Tile

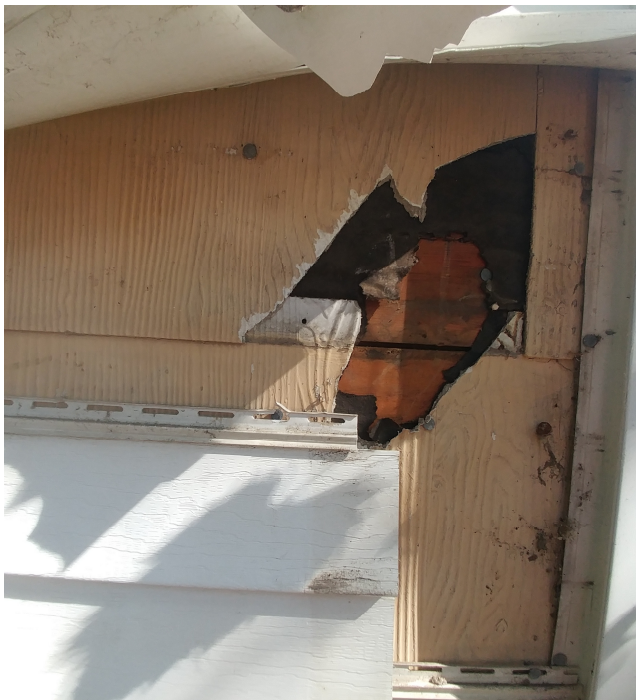
Pos. Transite

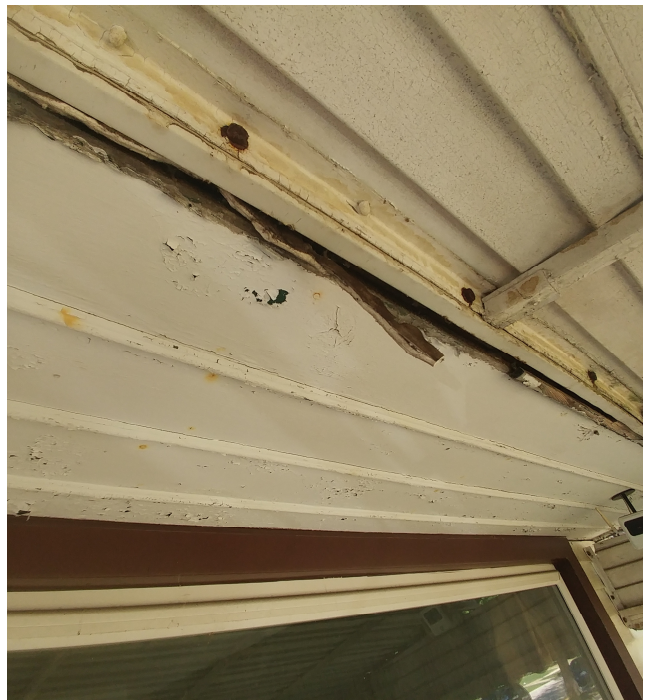
Pos. Window Glaze
